Inspection Report

Property Address:

Your Home

First Choice Home Inspections

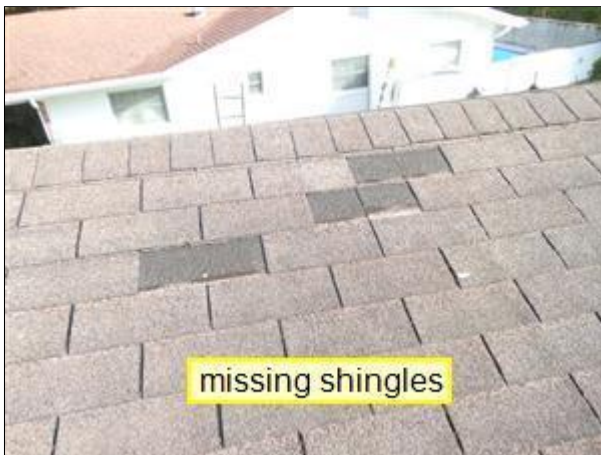
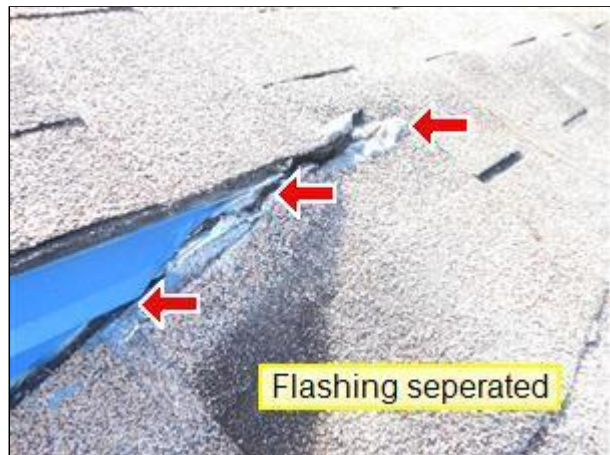
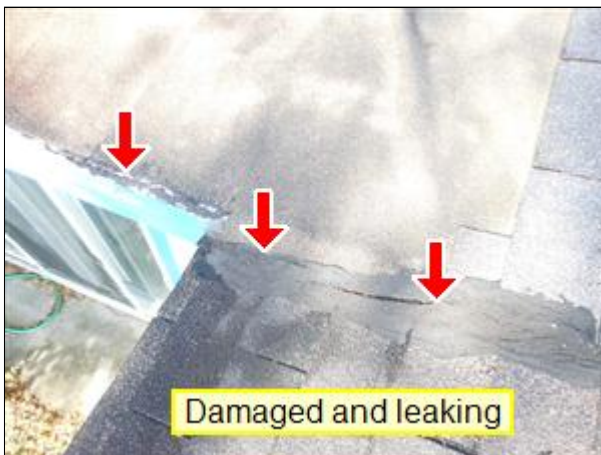
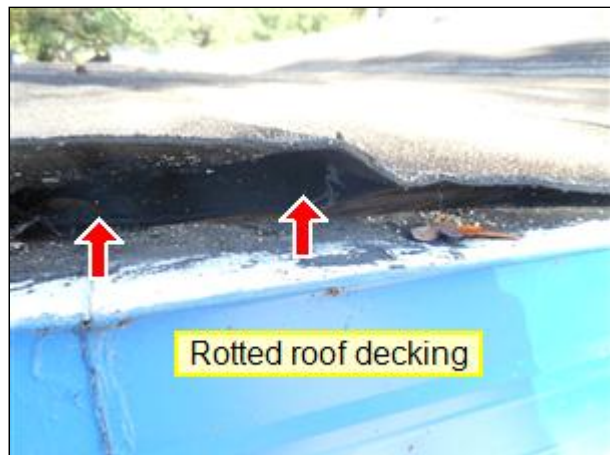
1.0 Picture 1

The roof covering is old, and the life of covering has expired. The covering does need to be replaced. While it could last a year or so, some areas may need patching with tar as leaks develop.

The roof covering is missing several shingles at the right side (facing front). Roof flashing is separated at the front gable tie in and appears to leak. Flat roof is not sealed along edge properly and wood deck is damaged at the rear section where flat roof ties into main. A qualified contractor should inspect and repair as needed.

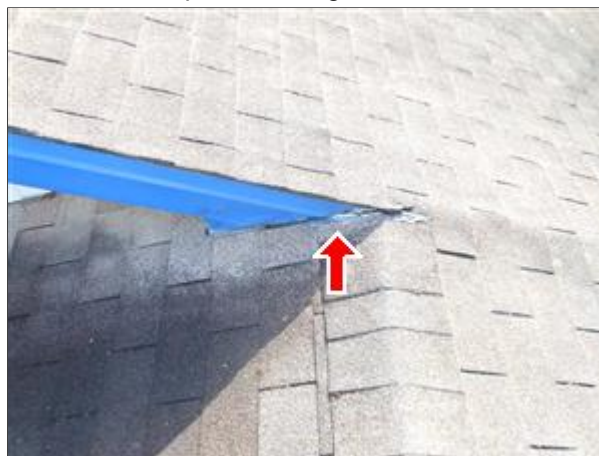
1.1 Picture 1

The flashing is separated and loose and needs repair at front gable.

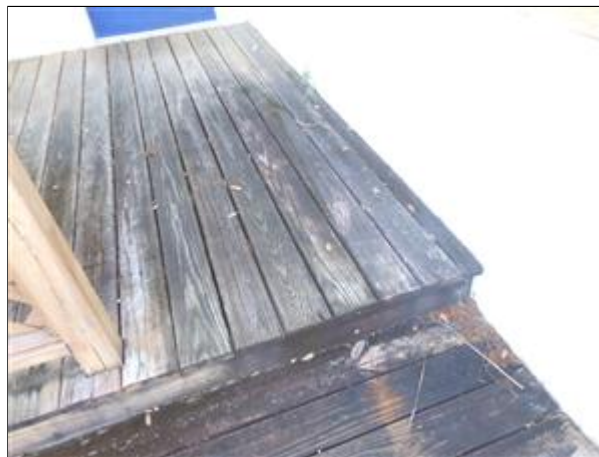
2.3 Picture 1

The deck needs cleaning with a "Deck wash" and seal with a waterproof sealant. Also, do the underside of deck if accessible.

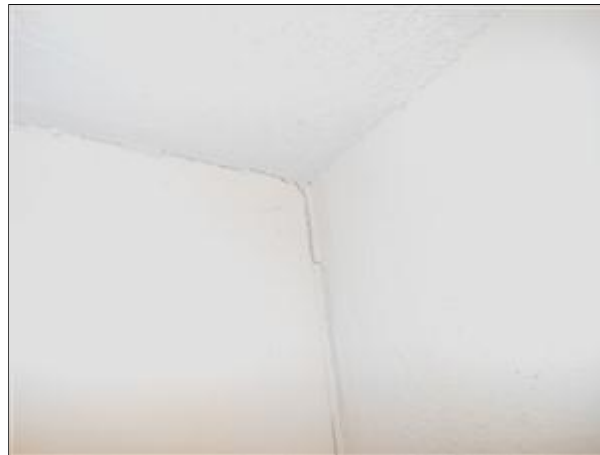
3.1 Picture 1

Loose drywall tape joints and poor quality workmanship noted in the master bedroom addition and utility room areas.

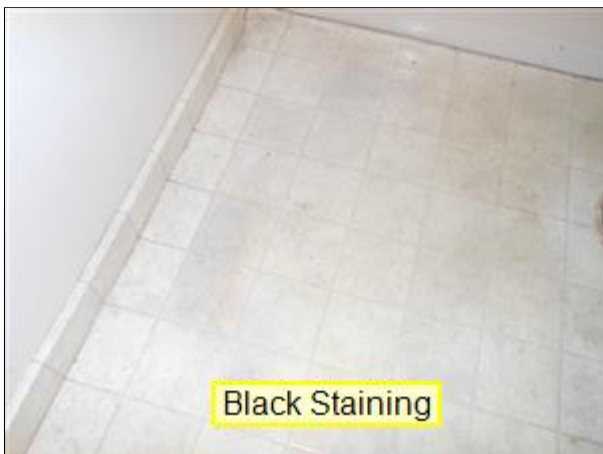
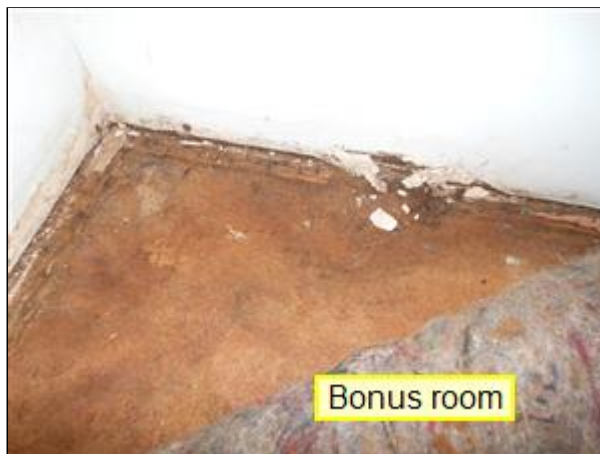
3.2 Picture 1

The vinyl / linoleum and under carpet shows staining indicating moisture or intrusion did or still may occur at the guest bathroom and bonus type room off the laundry. There is also the possibility of mold. A qualified contractor should inspect and repair as needed.

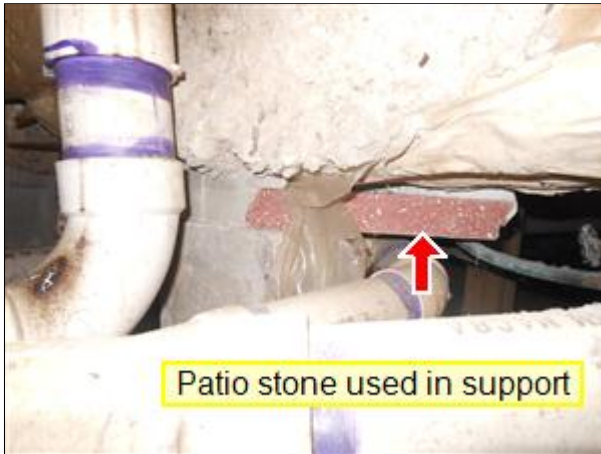
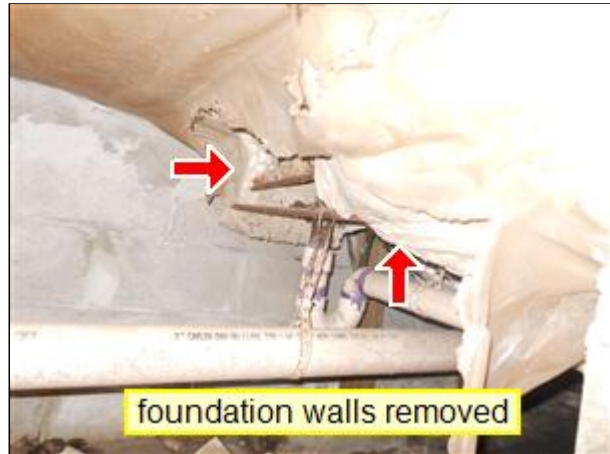
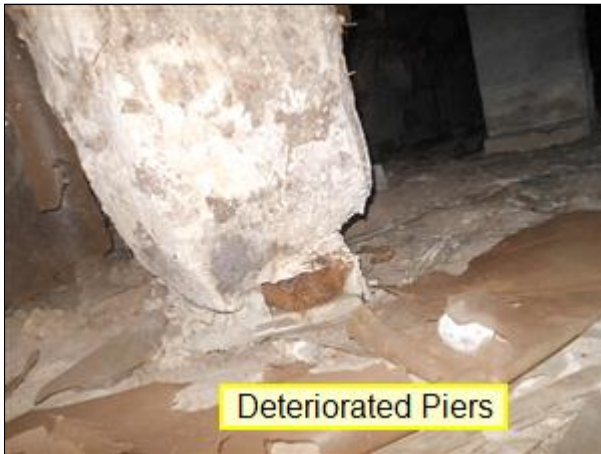
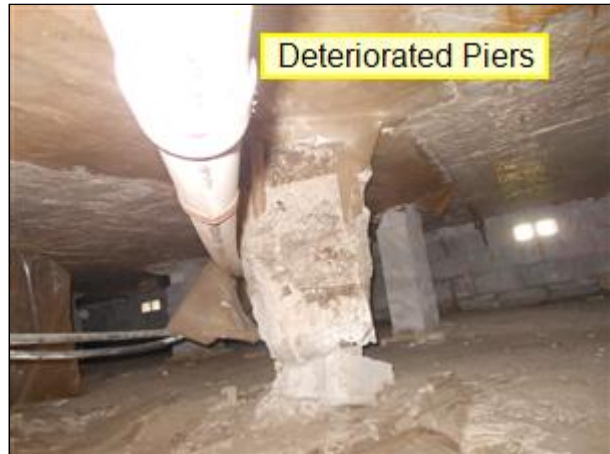
4.2 Picture 1

(1) The concrete piers are deteriorated and does not sit on a proper concrete footing in the crawlspace. Portions of the original homes foundation walls have been removed for additions. A qualified licensed general contractor should inspect further and repair or advise as needed.

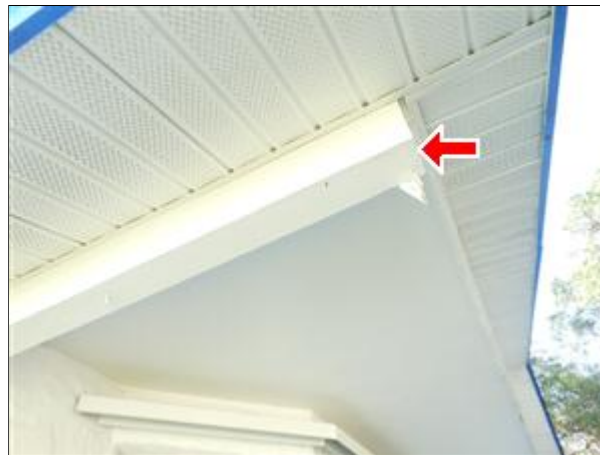
4.2 Picture 5

(2) It appears that there was once a support post that has been removed on the NW corner of the exterior of home for roof overhang. Reason for removal is unknown.

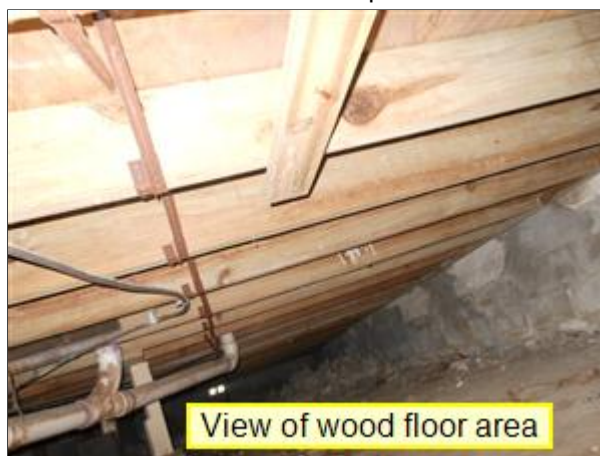
4.3 Picture 1

The floors are visually functional and in serviceable condition. Inspection is limited due to floor coverings.

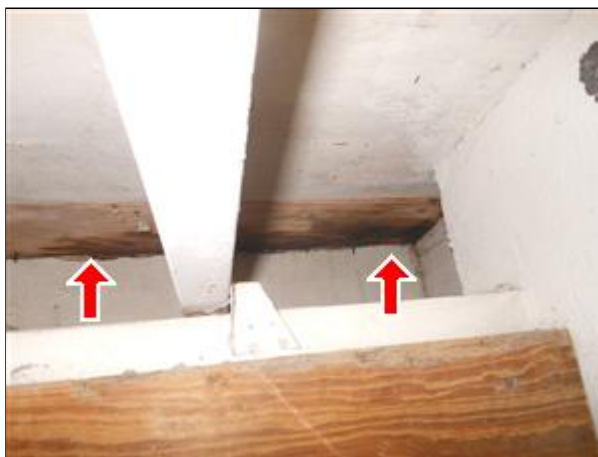
4.5 Picture 1

The roof trusses and plywood roof decking is consistent with standard building practices at the time of construction. The roof structure appears functional. There is some moisture intrusion noted in the SW corner of carport. Stains tested dry with a moisture meter.

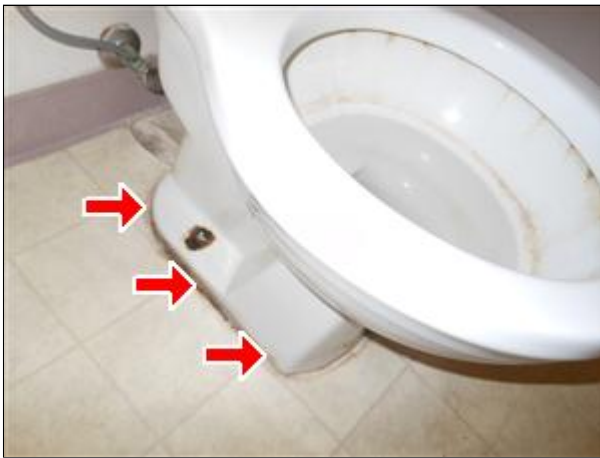
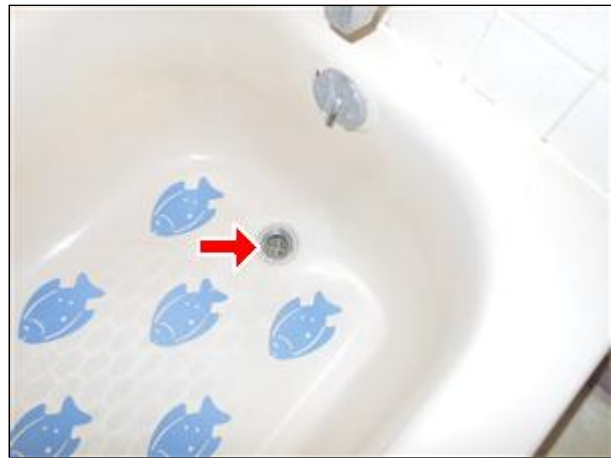
5.0 Picture 1

The toilet is loose at floor at the guest bath. Repairs may involve re-setting the toilet on a new wax seal. I recommend a qualified licensed plumber repair or correct as needed. The tub stopper is not functional.

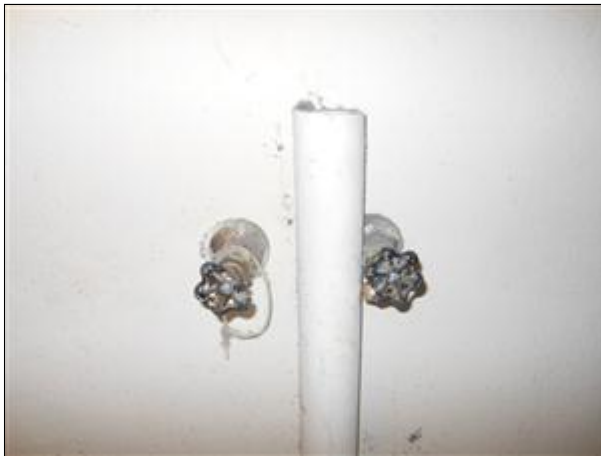
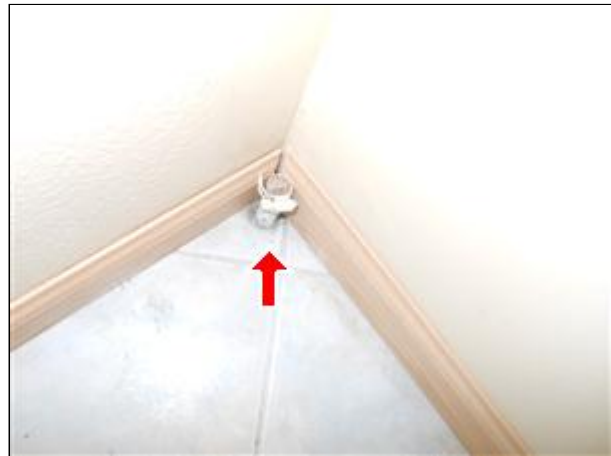
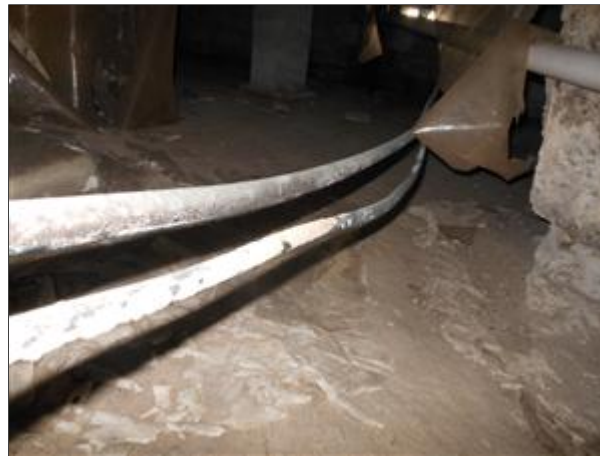
5.1 Picture 1

I recommend supporting some of the hanging water supply lines under the better.

The laundry faucets are capped off with threaded caps. This is probably due to faucets are leaking. Repair as needed.

There is a copper pipe stubbed up in corner of living room next to kitchen that appears to be a plumbing pipe. It is plugged with a piece of wood and strap. It was not determined if pipe is connected to water but I recommended that it be properly capped.

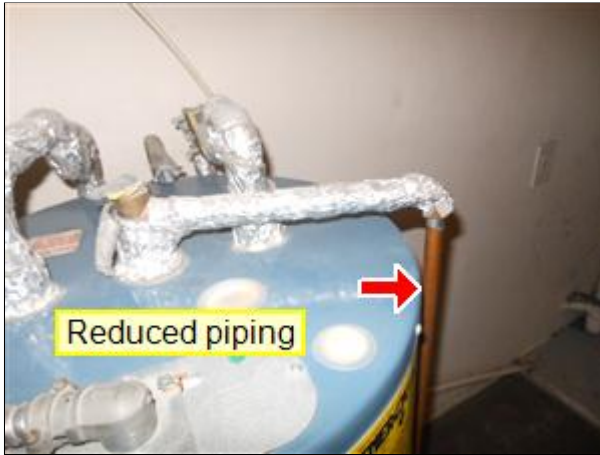
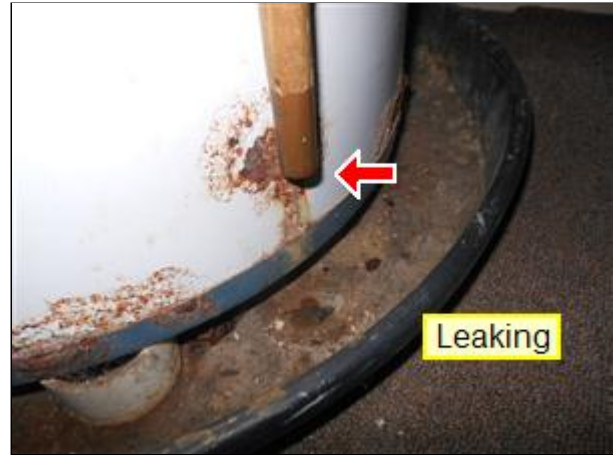
5.2 Picture 1

The water heater is old, rusted and at the end of its life expectancy. No leaks at present. A replacement will eventually be needed.

The existing piping for T&P valve on water heater is wrong diameter or size and the valve is leaking. Piping must be 3/4 inch diameter for today's standards. A qualified licensed plumber should repair or correct as needed.

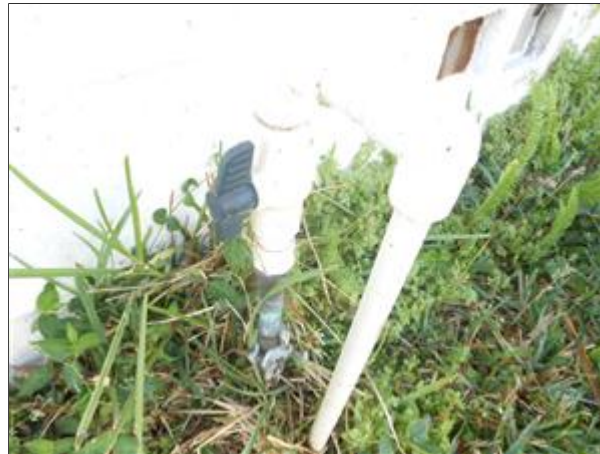
5.3 Picture 1

The main shut off is the black handle located outside on the left side wall facing front. This is for your information.

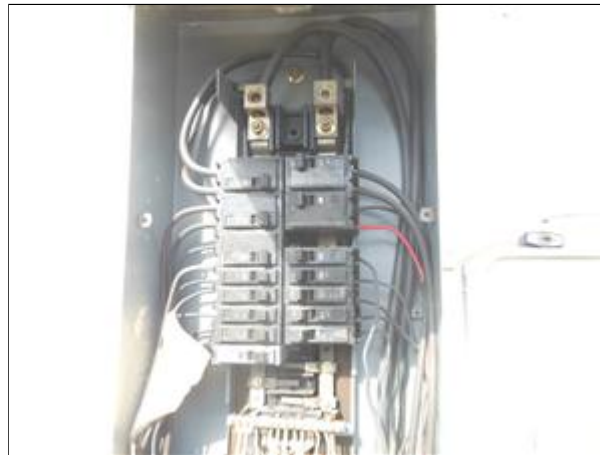
6.1 Picture 1

The electric panel appears to be functional and in serviceable condition.

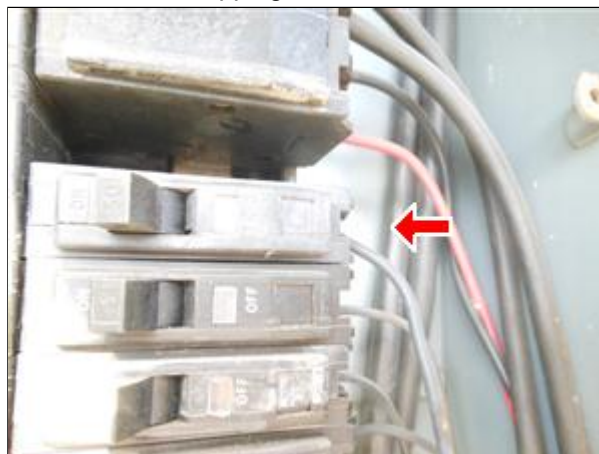
6.2 Picture 1

(1) Breaker # 14 in the main panel is a 30 amp breaker that is connected to a wire that is only rated for 20 amps. This is a hazard that could possibly overload wire without tripping breaker. Have an electrician evaluate and repair as needed.

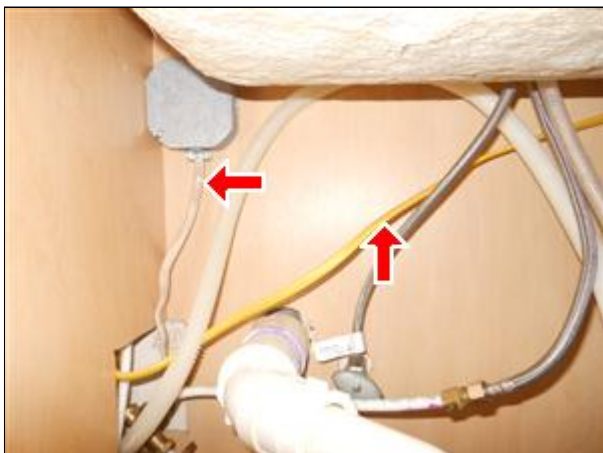
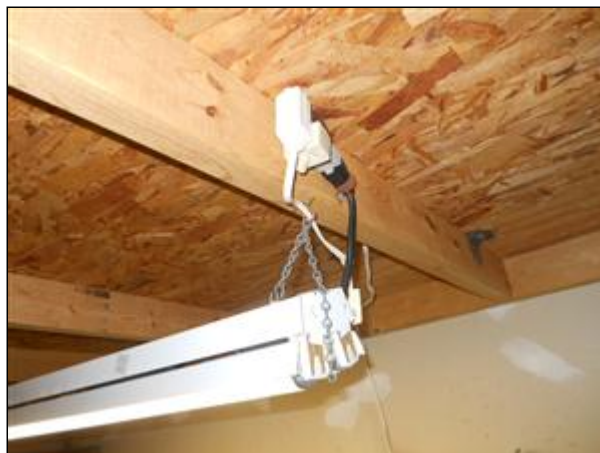
6.2 Picture 2

(2) Extension cords are used for lighting wiring in the carport storage and laundry closet. I recommended permanent wiring be installed. Cords are for temporary use only. It is also recommended that wiring under kitchen cabinets be installed in conduit.

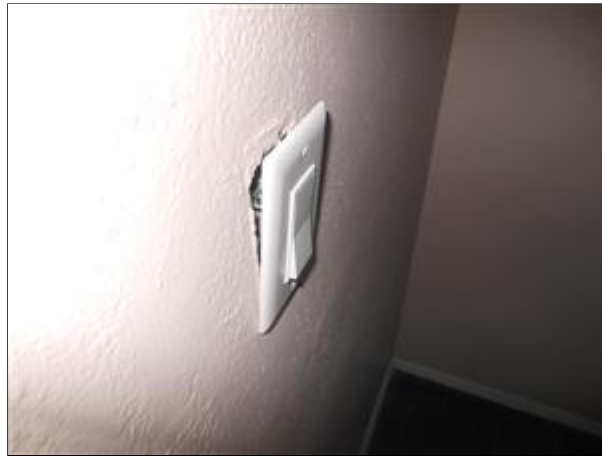
6.3 Picture 1

(1) The wall switch (for light fixture) is loose in the wall at the Master Bedroom closet. . I recommend repair as needed.

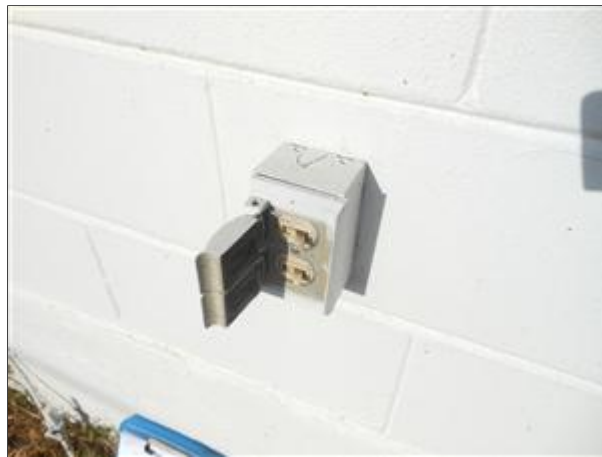
6.3 Picture 2

(2) It was not determined what the wall switch on rear exterior control. Ask the owner for information.

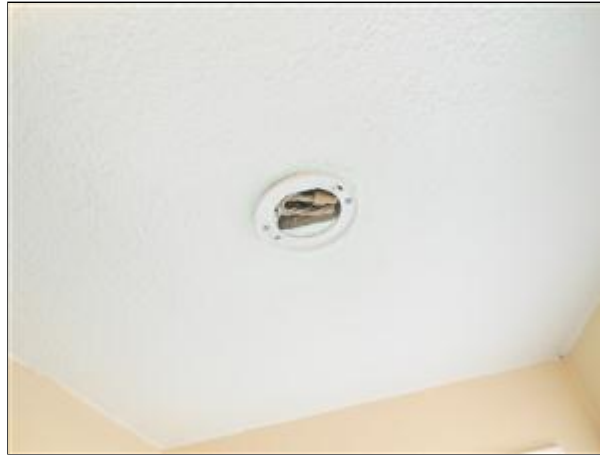
6.7 Picture 1

The smoke detector has been disconnected intentionally at the common hallway to bedrooms and there is no smoke detector in the master bedroom area. The smoke detector in living room area responded to test button. Without a working smoke detector in your home you have no first alert to a possible fire. I recommend repair or replace as needed using a qualified person.

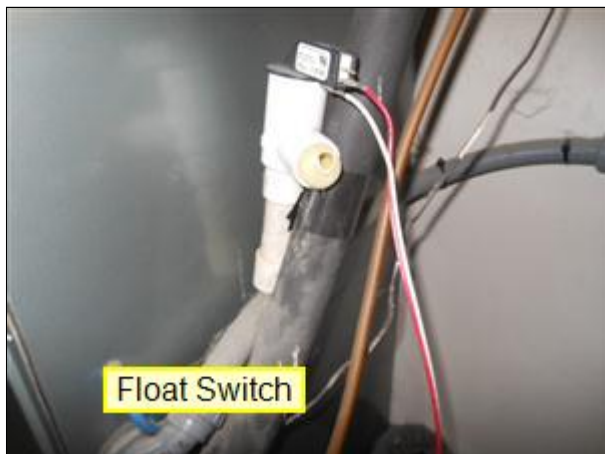
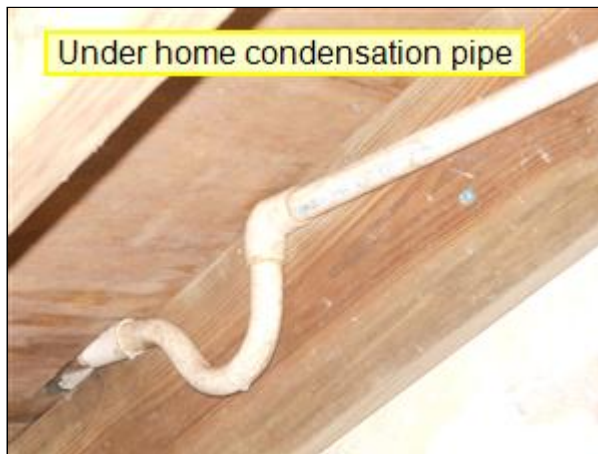
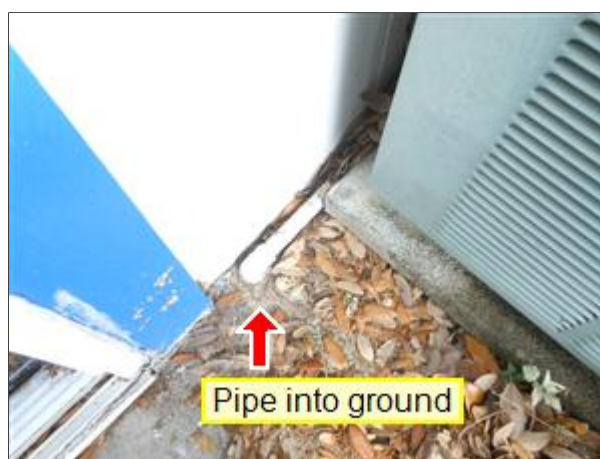
7.4 Picture 1

(2) The float switch is not properly connected to prevent condensation overflow and the condensation pipe is not properly insulated to prevent moisture from dripping in the home and under the home. I also do not know where

condensation pipe terminates on the exterior, it appears to go into ground by the a/c unit. Have a contractor evaluate and repair as needed.

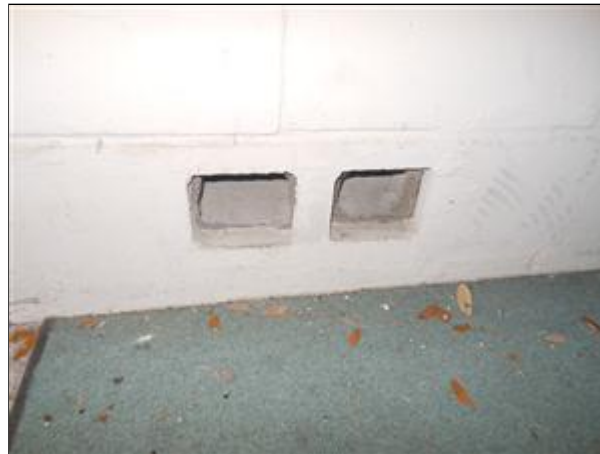
8.3 Picture 1

I recommend increasing the ventilation when roof covering is replaced. Install screening on vent hole on foundation wall in carport area to prevent pest from entering crawl space.

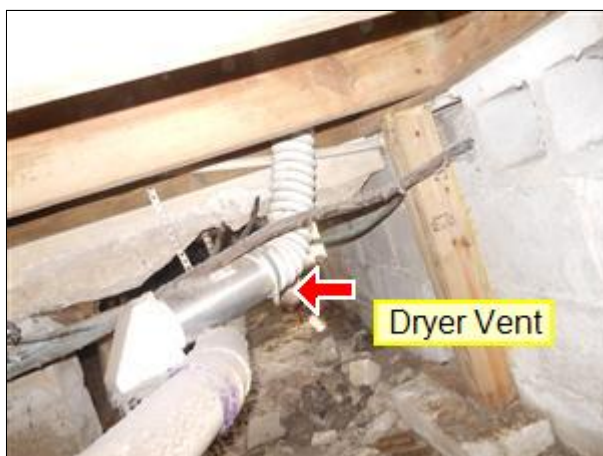
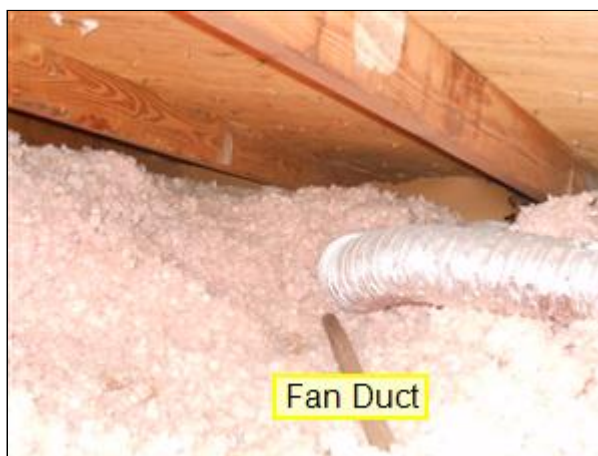
8.4 Picture 1

The dryer vent piping terminates in the crawlspace and vent appears to be clogged with lint, I recommend it be cleaned and vented to an exterior location.

The Exhaust fan at the master bath vents to soffit area. Vent pipes should terminate outside and not in the attic. Many homes have their vent pipe poised at the roof vent such as yours. It is up to you to determine whether or not this is a concern or needs further consideration. I recommend that when roof is replaced the fan be ducted out the roof.
